Goose Creek Report Card 2013

This report card summarizes water quality results based on data collected by the Goose Creek Association and the VA Department of Environmental Quality from January 2013 to December 2013 at the stations on the map, except for benthic data. Monitoring data was assessed against threshold values for each indicator at each site by determining the percentage of samples passing the thresholds over the period of interest. The grades for each site were then averaged together to determine an overall watershed score for each indicator. Benthic scores are based on data collected from 2000 to 2010 and synthesized into an Index of Biological Integrity for the watershed.

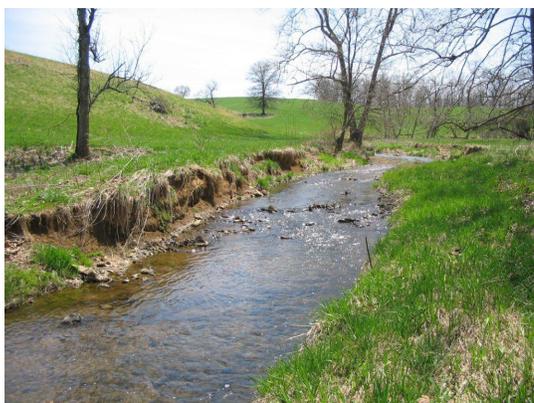
Stream bank erosion on Bolling's Branch.

Streamside areas that lack riparian forest buffers are prone to erosion. When riparian forest buffers are not present, stream water temperature rises, which can be detrimental to aquatic organisms. In the absence of riparian forest buffers, sub-surface nutrients are not taken up or reduced prior to entering the stream with groundwater.

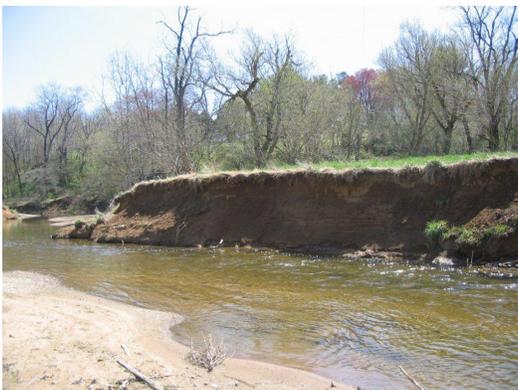
Eroded stream banks create sediment bars and reduce aquatic habitat.

Benthic macroinvertebrates are freshwater organisms that live in the stream and on the river bottom. Insects such as dragonfly larvae need a stream habitat with many rocks and little sediment and erosion in order to survive. The abundance and diversity of these organisms is a great indicator of stream health. The Chesapeake Bay watershed Index of Biotic Integrity compares benthic data to reference conditions and rolls the information into individual scores for subwatersheds. The table to the left shows the IBI score for each Goose Creek subwatershed based on data collected from 2000 to 2010 (the most recent data available). The scores are very poor for Lower Goose Creek subwatershed, which could be due to the higher amount of development in that area. Usually erosion increases and buffers decrease in more developed areas, which contributes to poorer stream habitat.
