# Hazel Run: A Watershed at Risk

Publishing Date:  
August 2010

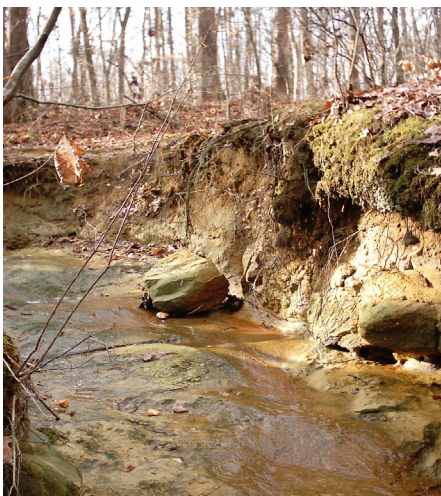
Example of streambank erosion.

Hazel Run is a tributary to the Rappahannock River that flows through Spotsylvania County and the City of Fredericksburg. It is listed as an impaired stream due to bacteria levels that exceed state standards. As a result of ongoing development over the past couple of decades, there has been an increase in runoff and decline in water quality and biological diversity in this 17 square mile watershed. The increase in stormwater runoff also contributes to major streambank erosion (as seen in picture on left).

Hazel Run is a watershed at risk because impervious surfaces (parking lots, roofs, etc.) from development contribute to polluted runoff. These larger amounts of runoff are more than this watershed can handle, as evidenced in the streambank erosion and high bacteria levels. However, it is not too late to clean up Hazel Run. Here are a few ways you can reduce stormwater runoff and bacteria pollution in the stream:

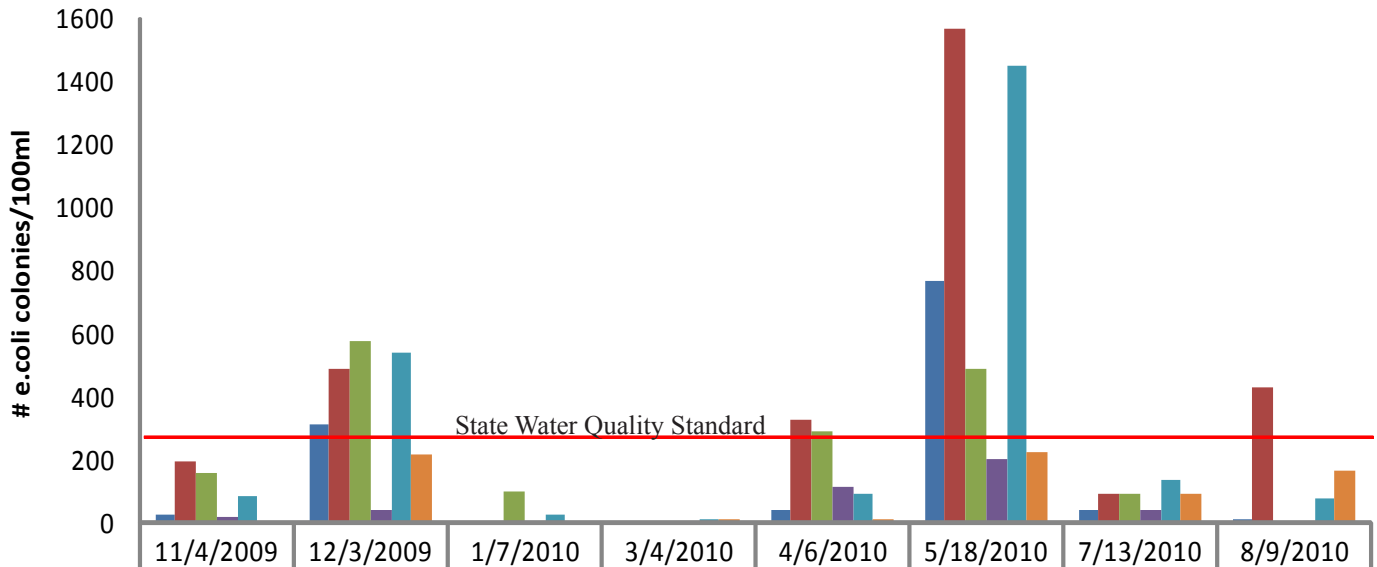
## Hazel Run Bacteria Data

11/4/2009	12/3/2009	1/7/2010	3/4/2010	4/6/2010	5/18/2010	7/13/2010	8/9/2010
FOR 1	25	312.5	0	0	37.5	762.5	37.5	12.5
FOR 6	191.7	487.5	0	0	325	1562.5	87.5	425
FOR 7	158.3	575	100	0	287.5	487.5	87.5	N/A
FOR 9	16.7	38	0	0	112.5	200	37.5	N/A
FOR 11	83.3	537.5	25	12.5	87.5	1450	137.5	75
FOR 12	0	212.5	0	12.5	12.5	225	87.5	162.5

Approximately once a month, from December 2009 to August 2010, volunteer monitors gathered *E. coli* data at 6 locations throughout the Hazel Run watershed. Eleven out of 46 samples exceeded the state water quality standard (as indicated by the red line). Also, the higher counts of *E. coli* occurred during storm events. In December and May, the average regional rainfall was about 1.85 inches and 1 inch, respectively. The higher counts of bacteria during those months show that bacteria is carried to the streams via runoff.

Site FOR 1 is located in Alum Spring Park, a popular spot for hiking, picnicking, and families and dogs playing creekside. Since

unacceptable bacteria levels have been found here, visitors to this park should take care to wash their hands before eating if they have been playing in or near the creek.

Site FOR 6, which is on the main stem of Hazel Run, close to where it empties into the Rappahannock River, typically has higher *E. coli* counts than the other sample locations. Volunteers have also indicated that even though a broken sanitary sewer pipe has recently been replaced, there is still a sewer smell in the area. More research and sample collection will need to be conducted to determine the potential bacteria sources.

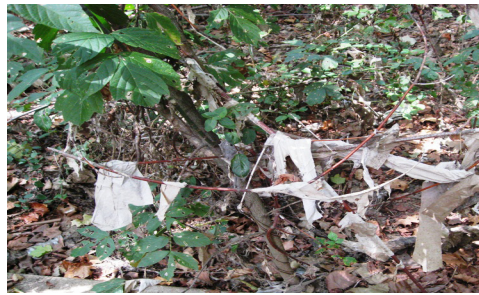
Sewage overflow near Hazel Run.

- Pick up after your pet.
- Install a rain barrel or rain garden and plant native species to keep stormwater on your property.
- Watch (and smell) for sewage overflows and contact your city or county.
- Support sewage treatment plant upgrades.
- If you have a septic system, have it inspected and pumped regularly.
- Volunteer to be a water quality monitor.

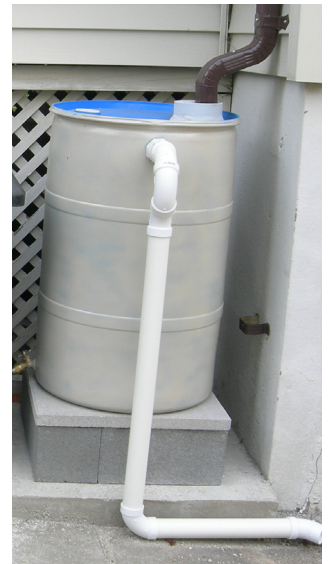
Rain barrel captures runoff.
